Evaluation of Transverse Joint Forming Methods for PCC Pavement

National Concrete Pavement
Technology Center

Final Report
January 2006

Sponsored by
the Iowa Highway Research Board (IHRB Project TR-532)

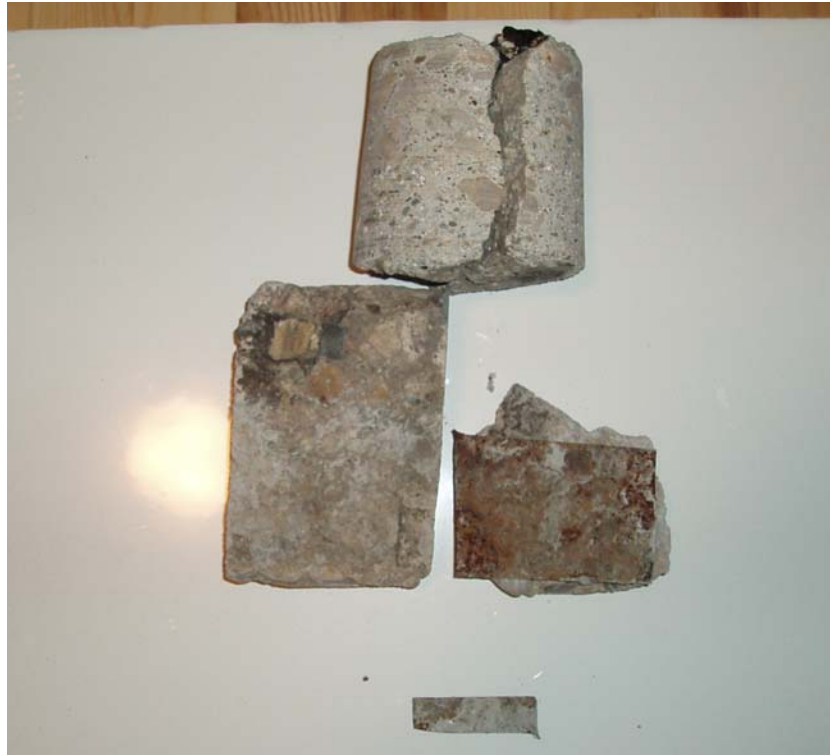
Figure A1. Core 1

Inspiration for the present research arose from two sources. The first source is two cores taken from a former state highway in north-central Iowa. The two cores of transverse cracks, taken at random locations in a 16-km (10-mile)-long project, yielded vertical steel materials at the bottom of the slab. These cores are shown in Figures A1–A3 in Appendix A. The cracks had migrated from the top of the steel strip to the pavement surface. The steel material was 76–89 mm (3 to 3.5 inches) in height and 3.2 mm (1/8 inch) in thickness. The crack formation and the randomness of the cores taken would indicate that the metal extends across the width of the slab. The surface cracks were very straight in alignment across the slab and had not spalled over time. The concrete in Figures A1 and A2 is approximately 24.1 cm (9.5 inches) in depth, and the core in Figure A3 is 27.9 cm (11 inches) in depth.

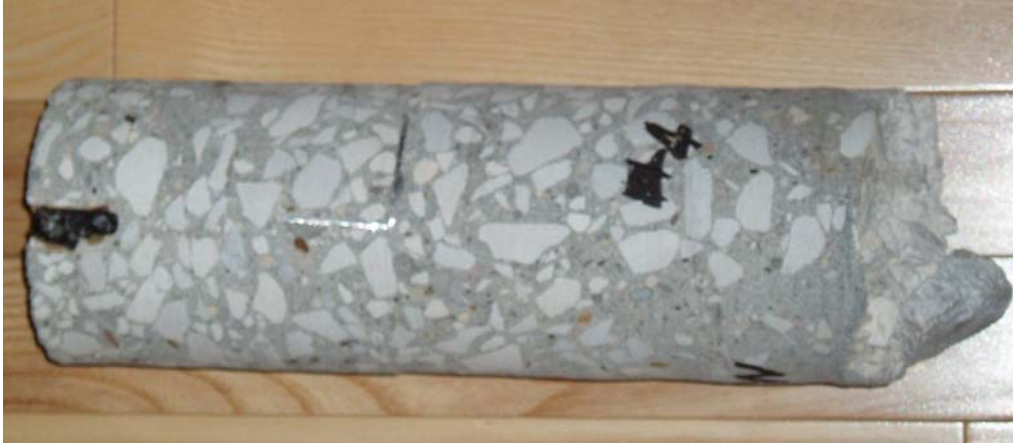
The cores indicate two specific details that may be of interest in the future. First, in section four the joint former is above the dowels and, as indicated in the photos, contains a crack that extends between the top of the metal and bottom of the sawed joint. The crack is highlighted by the center black ink mark in Figures G5 and G6 in Appendix G. It is not possible to tell which way this crack initiated, but the crack is of interest to the research.

Figure G4. Test section 4 core

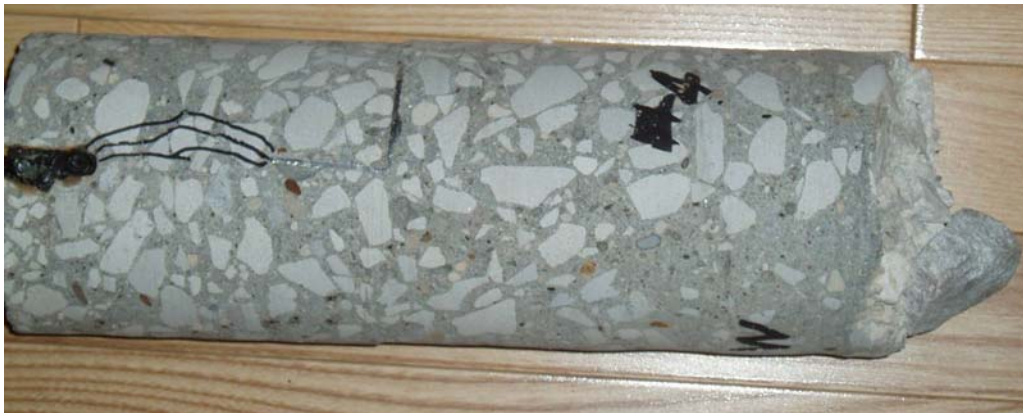
Figure G5. Crack in test section 4 core

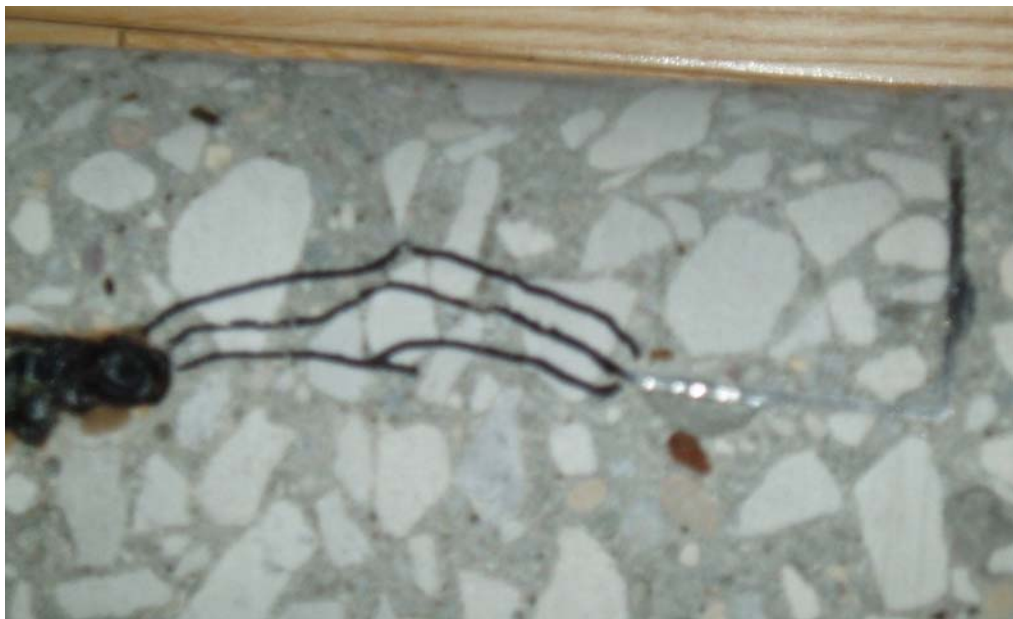
Figure G6. Close-up of crack in test section 4 core
